Limited Visual Dam Safety Inspection Summary Report

HI - 00049

Keaiwa Reservoir

May 2006

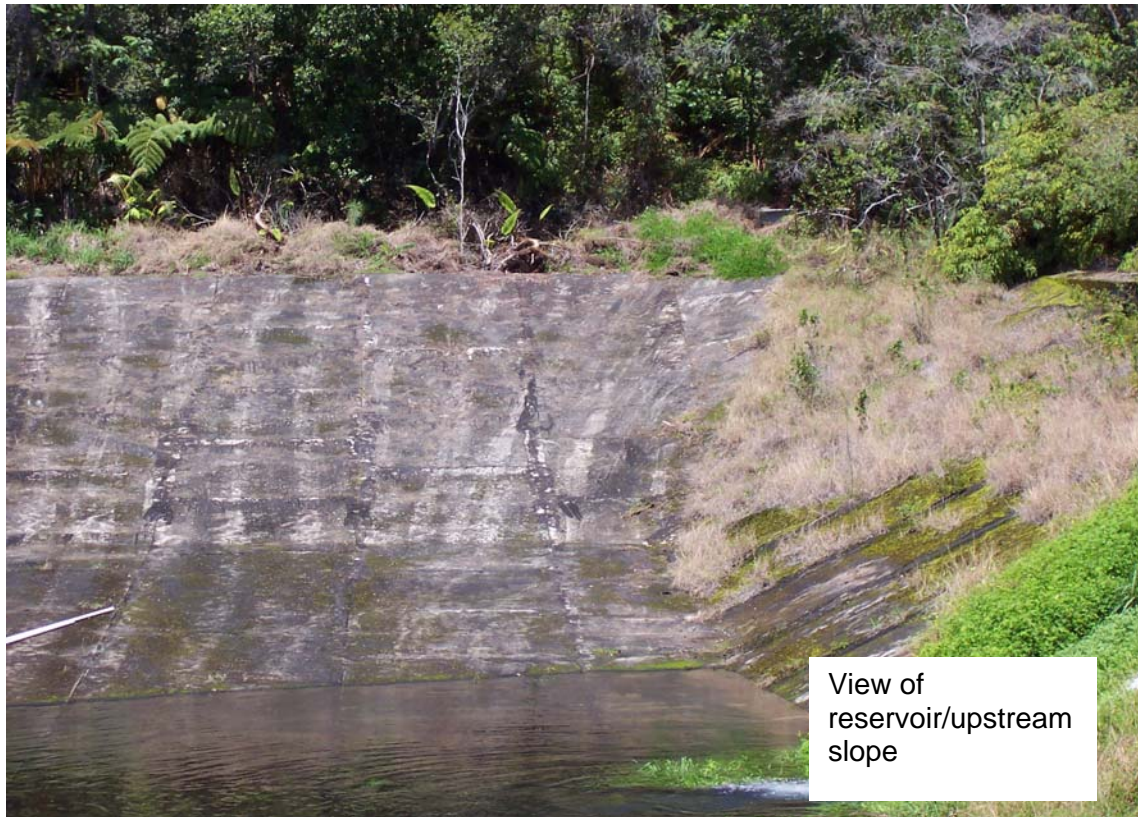
View of
reservoir/upstream
slope

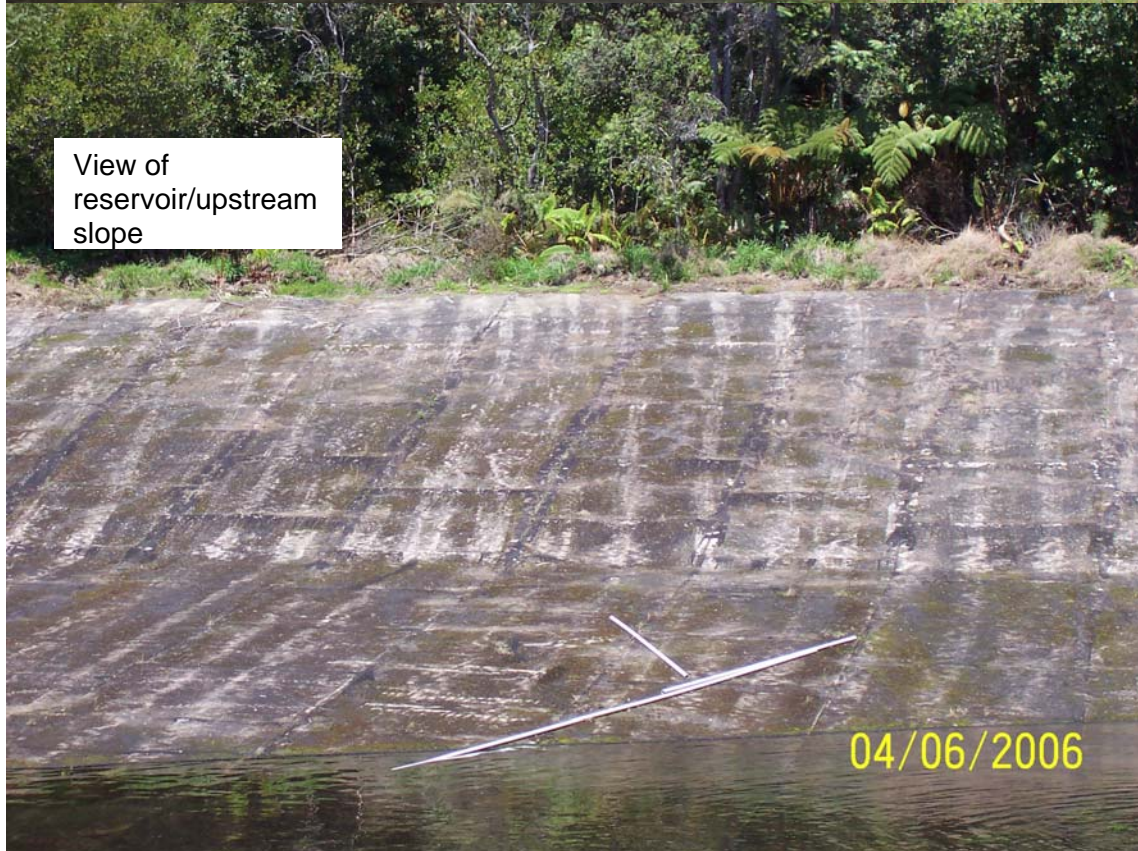
View of
reservoir/upstream
slope

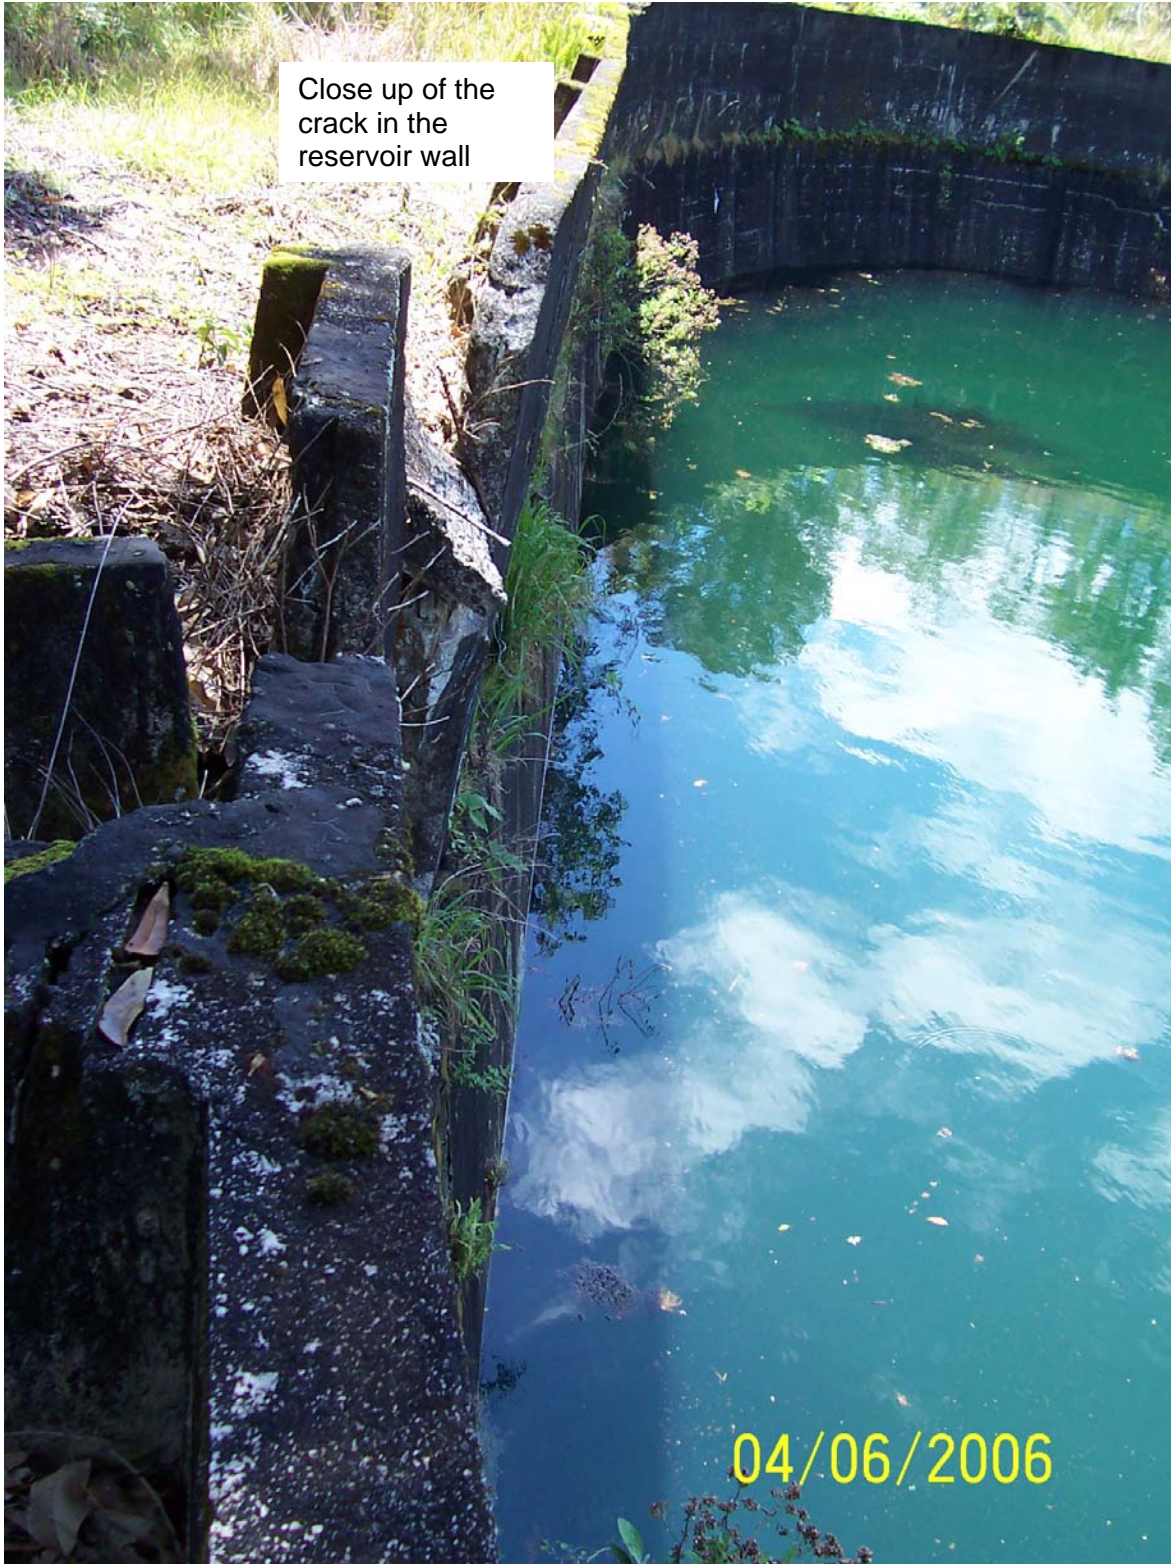
Based on staff personnel, this reservoir has an incident history of:
Cracking in the reservoir walls and spillway due to earthquake.

Close up of the
crack in the
reservoir wall

Crack in wall from EARTHQUAKE

- a. The reservoir was not fully inspected.
- b. The reservoir appeared to be in fair to poor condition and requires corrective action if the owner is planning to allow the reservoir to fill to levels higher than present.
- c. The crack in the wall as well as the condition of the reservoir requires assessment prior to allowing reservoir to fill to its full capacity.

- ☐ e. The staff gage needs maintenance and/or repair. Description: _____
- ☐ f. A staff gage was not observed at the reservoir. Provide some method of quantifying the water level within the reservoir.
- ☐ g. A sinkhole was observed in the upstream reservoir. Conduct additional investigations and monitoring to identify the cause, risk and appropriate action.
- ☒ h. NEED TO FIX FAULT IN UPPER PORTION OF WALL IF WILL USE TO MAX. CAPAC.
